INVESTIGATION AND REPAIR OF A HEAT EXCHANGER TUBESHEET-TO-CHANNEL FLANGE

ABSTRACT

During its fabrication hydrotest, the flanged joint between the tubesheet and the channel of a shell and tube heat exchanger leaked.

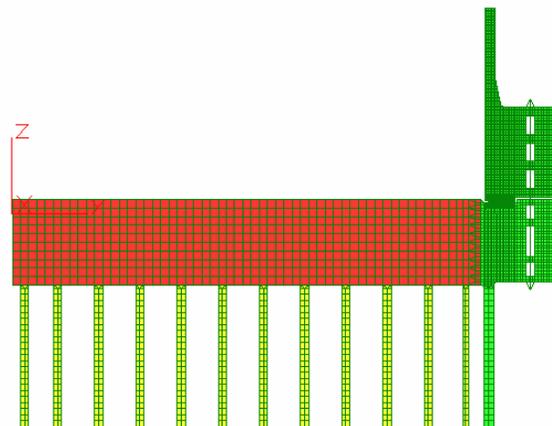
Figure 1
FE Model of Tubesheet and Flange

An FE model (Figure 1) was constructed using axisymmetric finite elements. The tube field in the tubesheet and the flange bolting are not truly axisymmetric. However, for preliminary investigations,

this lack of symmetry was not considered to be significant enough to have a major effect on the results. The tube influence on the tubesheet was approximated by use of equivalent axisymmetric rings

The gasket and flange contact surfaces were simulated with a row of elements. Elements that exhibited a tensile load at the gasket-to-flange interface were removed from the model. The model was then re-run. This process was repeated until only a compressive load remained at the interface. The thermal transient and steady state conditions were also investigated to determine their impacts on the established design.

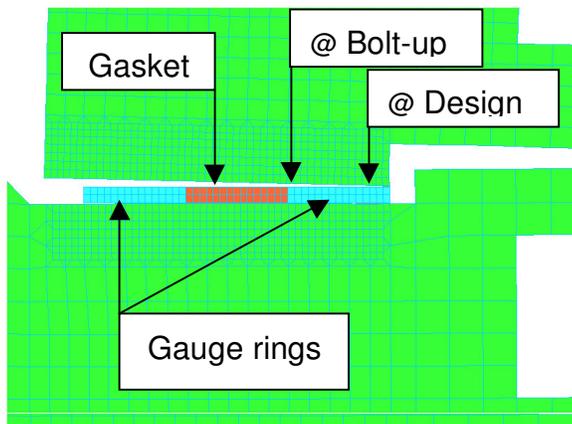
Figure 2
Deflected Shape with Contact Points Indicated

The rotation of the flange is strongly influenced by the hydrostatically induced expansion of the exchanger barrel. The final row in Table 1 indicates the flange rotation computed without the expansion of the barrel of the channel included in the model. This was done to determine the barrel's effect on the flange rotation. We can see that without the barrel's contribution, the rotation is considerably

less. This would seem to indicate that the current Code [1] flange rigidity index calculations may not accurately represent the flange rotation because they do not address the contribution of the barrel expansion to the flange movement. In the subject case, the hydraulic pressure expanded the channel barrel such that the flange became a restraint to the barrel's expansion. This caused the flange to rotate more than it would have with only the hydraulic end load applied.

As the flange rotates, the gasket's contact surface lifts away from the gasket. Table 2 provides the radius at which the gasket contact surface is no longer in compression. At the beginning of the original bolt up, the gasket is in contact with the complete surface. The gasket surface contact radius begins to significantly move outward as bolt up is completed and hydraulic forces develop. Thus, the rotation of the flange reduces the gasket contact surface and the resulting contact stress. Figure 2 indicates the rotation of the flange. From inspection of Table 2 and Figure 2, it is apparent that the contact point of the flange and gasket (where the resistance to the bolt load begins) is actually outside the diameter of the spiral-wound gasket and is instead on the outer gauge ring. This is true both at bolt up and at design pressure.

As we can see in Table 2, the model indicates that the outer gauge ring is no longer in contact with the flange before the hydrotest pressure of 461 psi is reached. During the actual test, the exchanger started leaking at a pressure slightly less than 400 psi.
